**Hoh River Miles 17 to 40: Oxbow Canyon and Mount Tom Creek**

**July 2004**

# **Summary Report for Geomorphic Assessment of Hoh River in Washington State**

## **River Miles 17 to 40 between Oxbow Canyon and Mount Tom Creek**

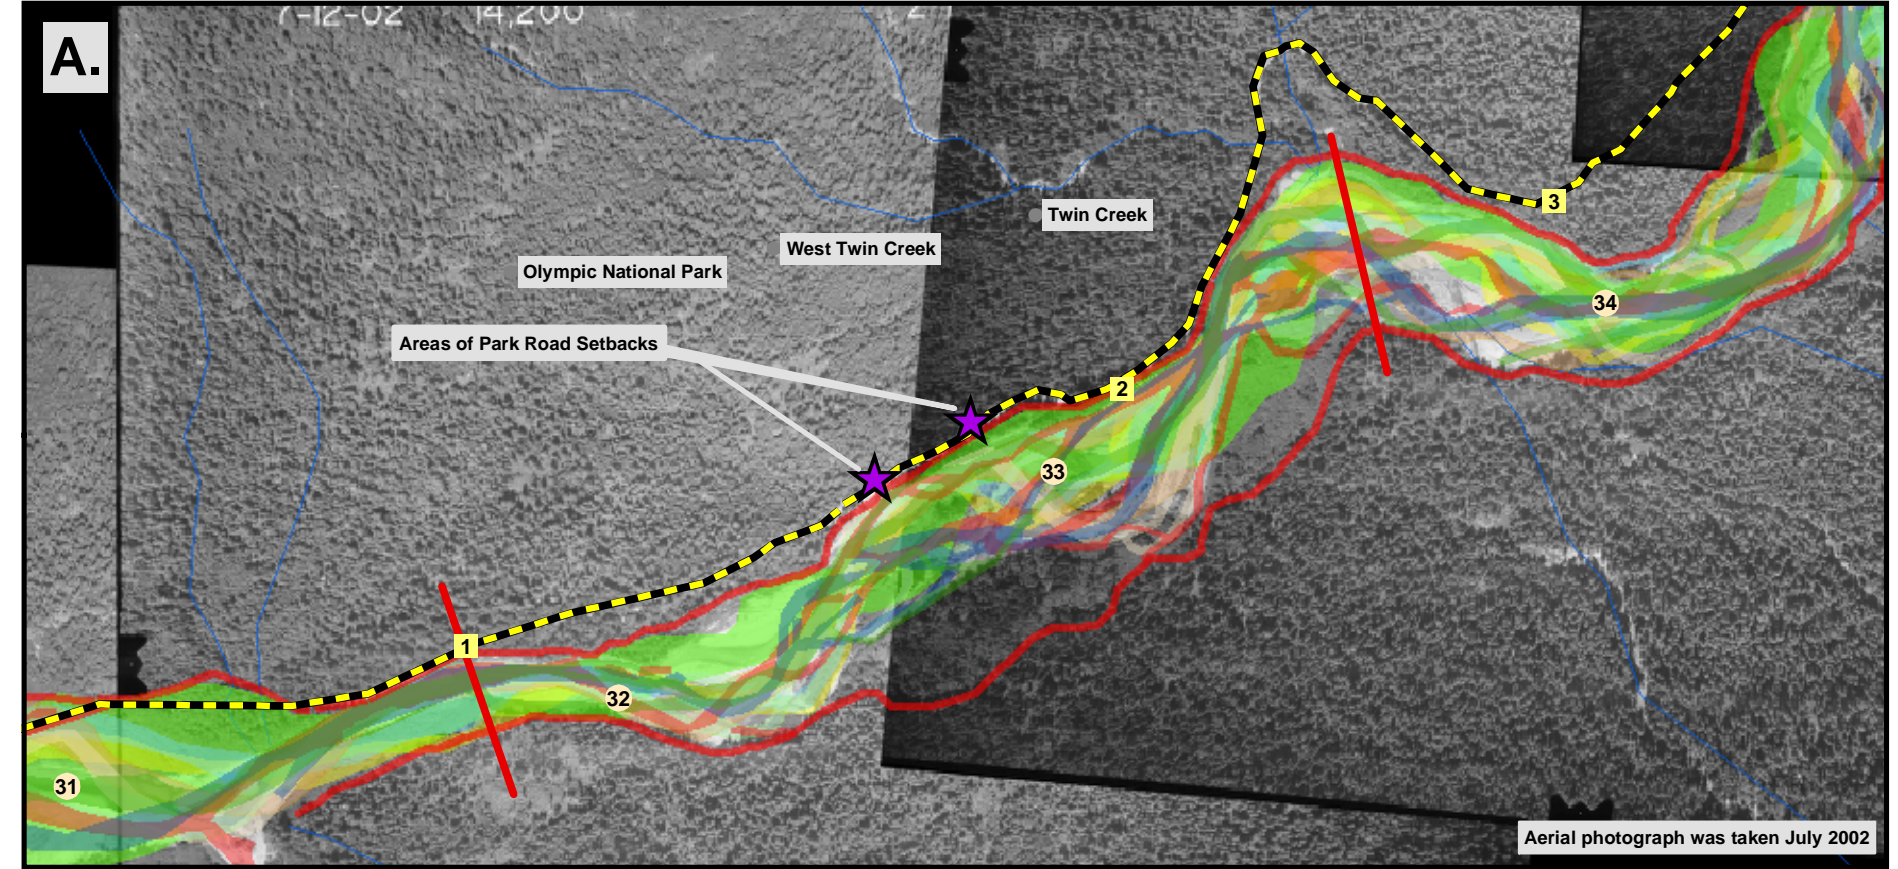
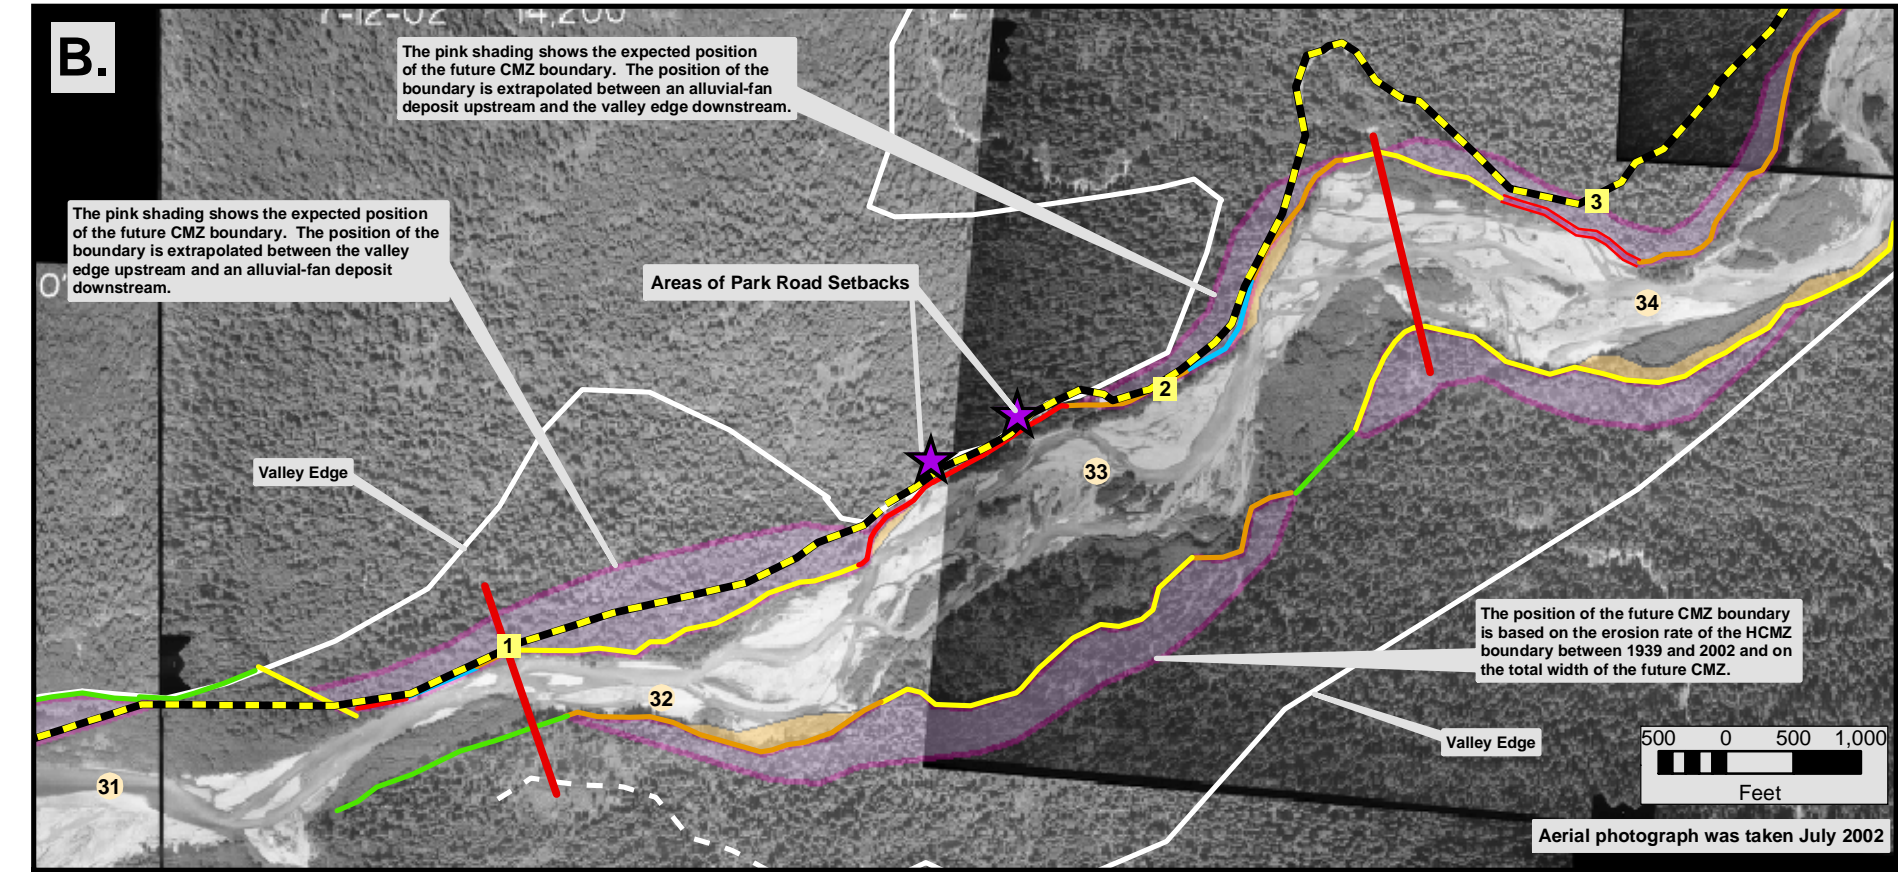
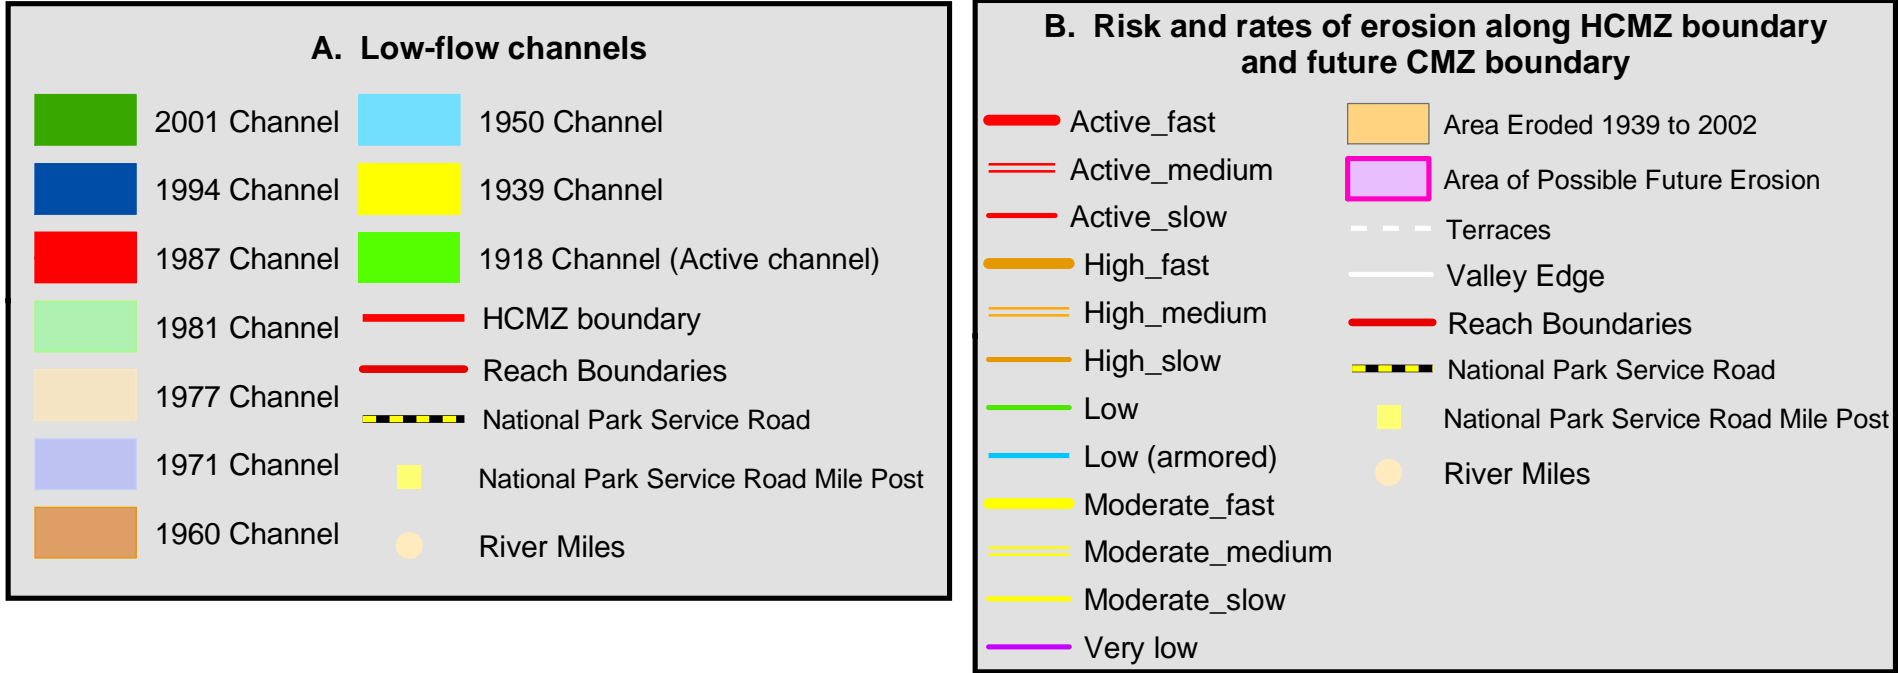
Figure 2.5. Historical channel position, risk assessment, and future channel migration zone boundary for the Twin Creek Reach.

B. The risk and rates of erosion are shown along the boundary of the historical channel migration zone (HCMZ) by the line segments in varying colors and patterns. Areas of the HCMZ that we speculate could erode in the near future are shown in pink and define the boundary of a future channel migration zone. Sections of the HCMZ boundary that lack pink shading will likely be stable in the near future, and lateral erosion of the boundary is expected to be minimal in these areas. The pink-shaded areas show the maximum extent of expected lateral erosion assuming that no human structures exist. If roads and protected banks are maintained, then they would be the limits of lateral erosion along the HCMZ boundary.

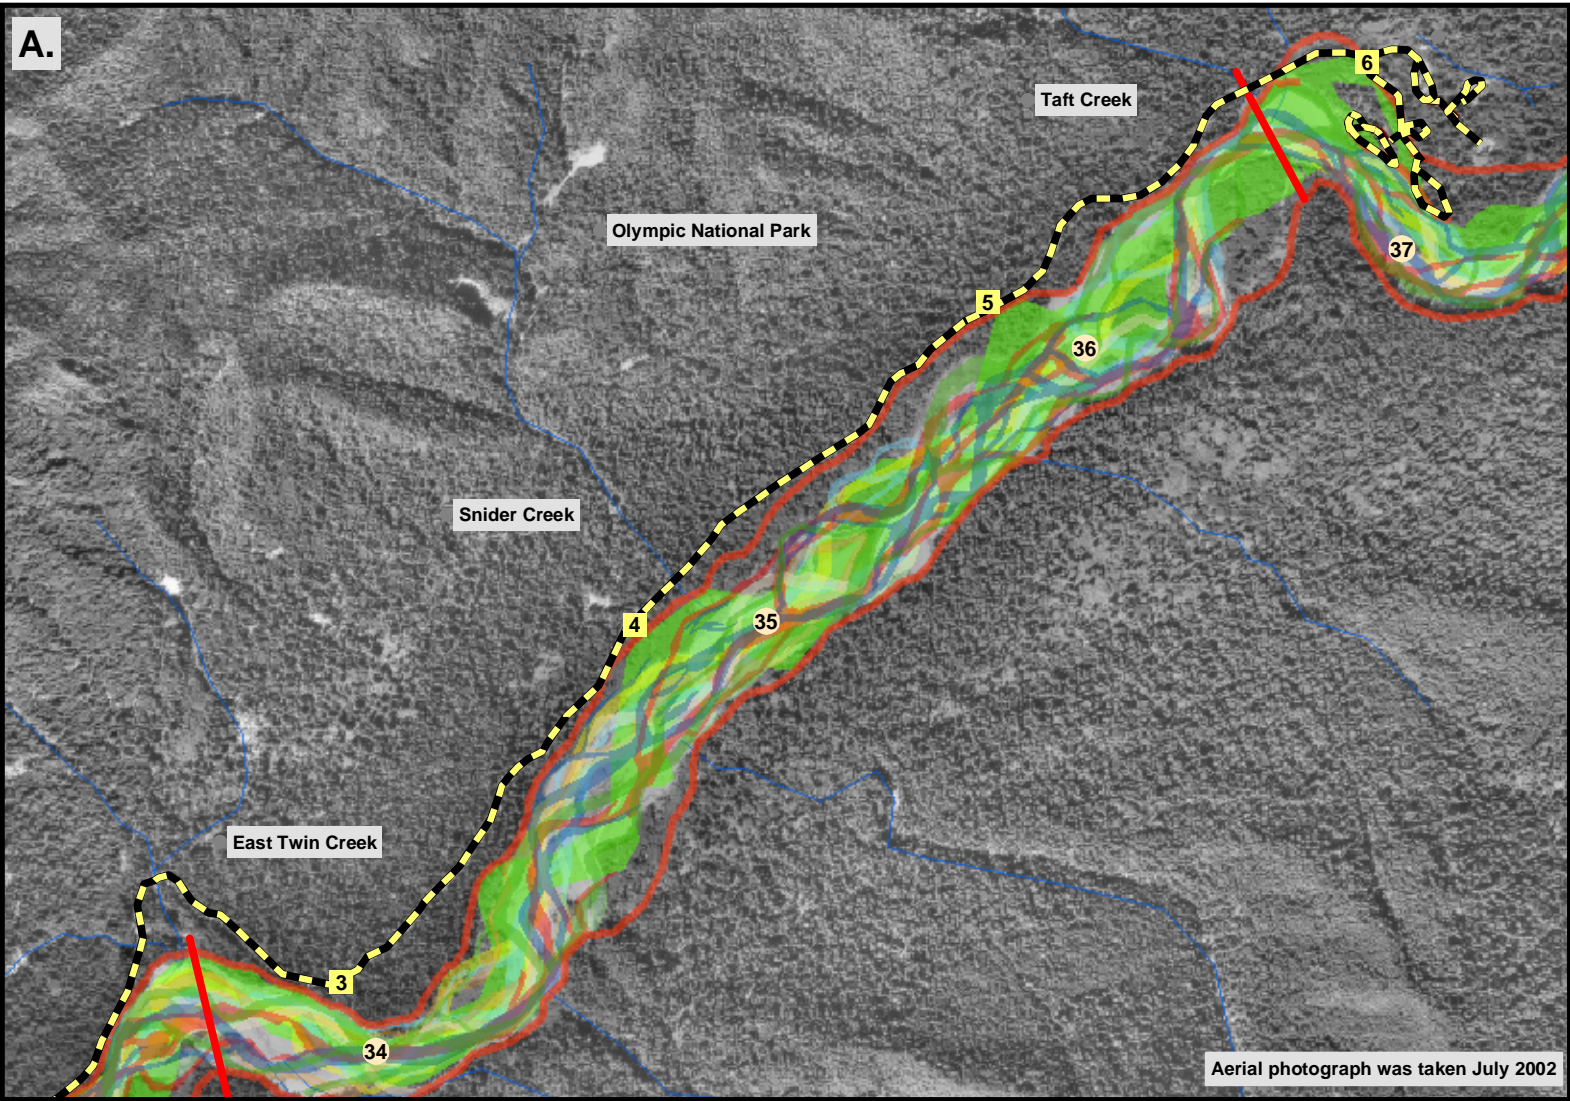
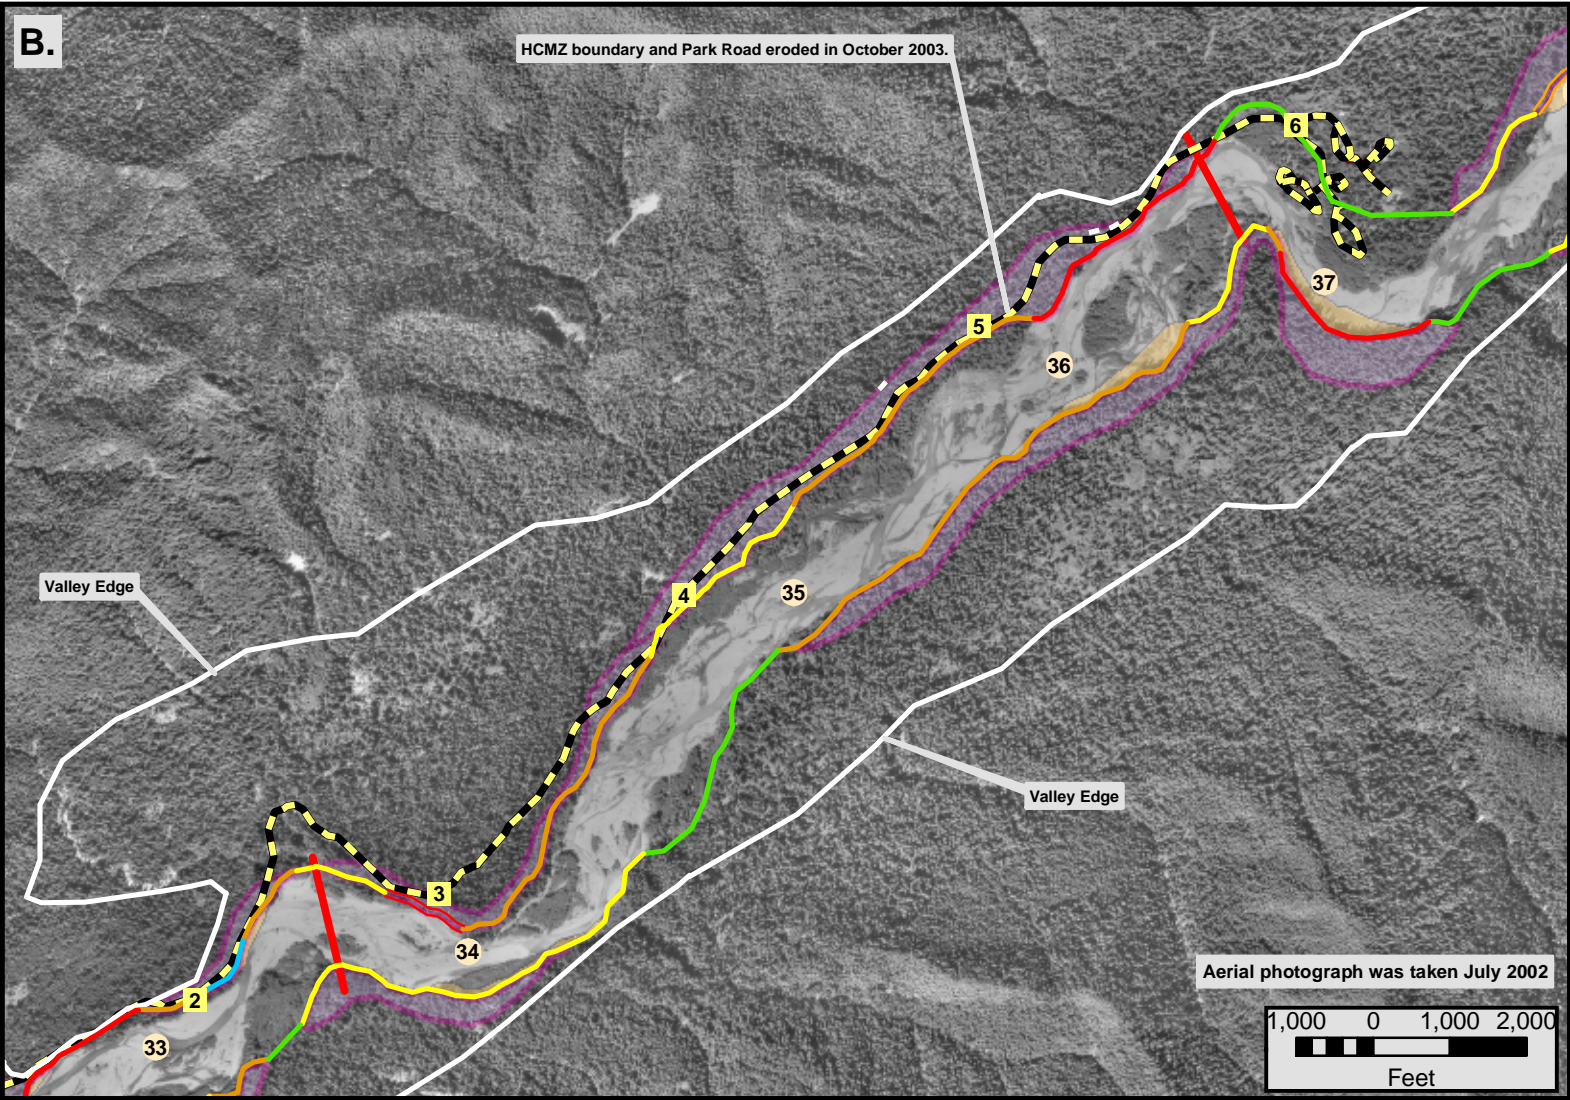
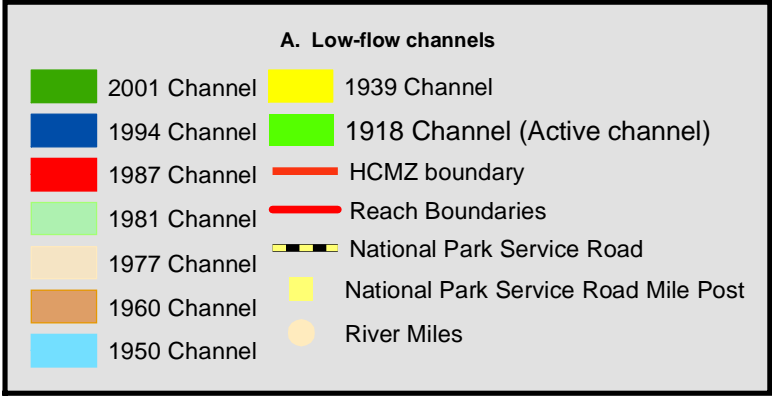
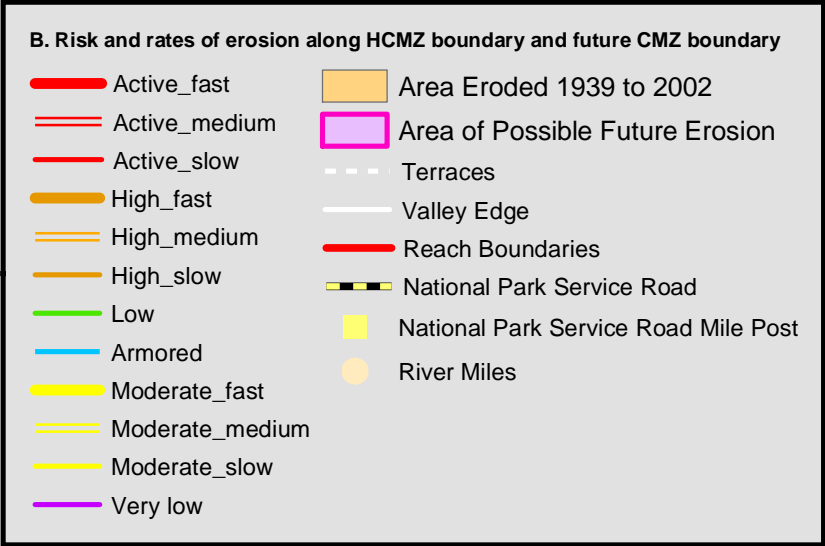
Figure 2.6. Historical channel position, risk assessment, and future channel migration zone for the Snider Creek Reach.

B. The risk and rates of erosion are shown along the boundary of the historical channel migration zone (HCMZ) by the line segments in varying colors and patterns. Areas of the HCMZ that we speculate could erode in the near future are shown in pink and define the boundary of a future channel migration zone. Sections of the HCMZ boundary that lack pink shading will likely be stable in the near future, and lateral erosion of the boundary is expected to be minimal in these areas. The pink-shaded areas show the maximum extent of expected lateral erosion assuming that no human structures exist. If roads and protected banks are maintained, then they would be the limits of lateral erosion along the HCMZ boundary.
